The work presented in this volume is concerned with the performance prediction, testing, and post-test evaluation of a representative graphite-fiber, resin-matrix aircraft fuselage component. Additional material properties were determined and structural margins of safety defined by discrete element analysis. After even response tests under various load combinations, the component was tested to destruction under combined bending and shear loads. Failure occurred at 110 percent of the target design load but below the failure load predicted from tests on flat panels. A weight saving of 27 percent over an aluminum structure of equivalent strength was demonstrated. The component was also three times stiffer than an aluminum structure of the same weight. Performance projections indicate that the same component built with presently available "Thornel" 50s fibers would offer a weight saving of 49 percent. Post-test evaluations included tensile and compression tests on curved skin panels, on stringers, and on stringer-skin combinations. Optical and electron microscopic examination of the fracture surfaces provided further insight into the failure mechanism.

B. <u>Preliminary Tests</u>
(S.L

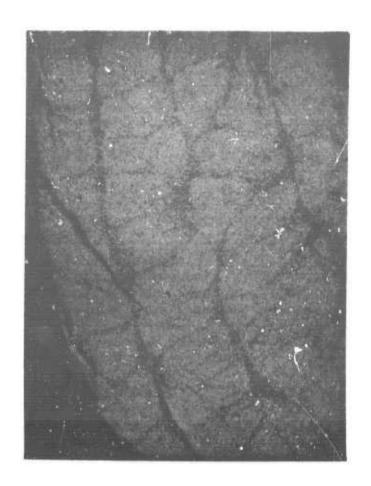
Figure 40. Photomicrograph of Web-Flange Section of Hat-Shaped Stringer Tensile Specimen, H50-223-2. 50X Magnification.

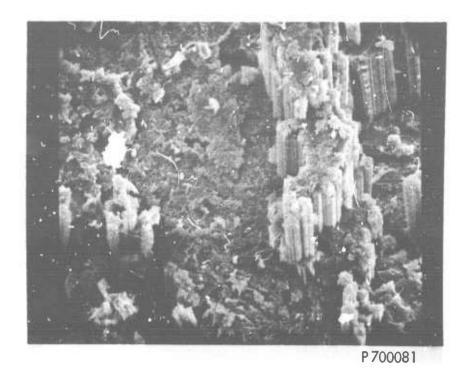
A closer examination of the fracture surface in the perpendicular region gave a further indication of the direction of crack propagation. When the stringers were bonded to the skin with a room temperature curing adhesive, excess resin collected at the skin-stringer bond region. A close examination of these regions of excess resin revealed fracture origins, mirror and feather markings of a crack propagating through each skin-stringer bond. From the location of the fracture origin and the orientation of the feather markings, the crack appeared to have propagated from the center (stringer No. 1) out to points B and C of Figure 41. Figure 48 shows the fracture surface characteristics of the excess resin of stringer No. 31. The crack appears to have initiated at the right (nearest to stringer No. 1) and propagated to the left. This observation is substantiated by the high speed

Figure 46. SEM Photograph of the Root of Stringer No. 1. 500X Magnification.
